IMPORTS OF TILES & STONE PRODUCTS FROM CHINA

SAFETY ALERT

IMPORTATION OF TREMOLITE ASBESTOS NATURAL STONE TILES

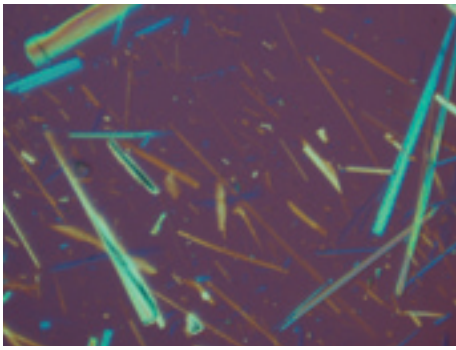
<p>Tremolite under 100 X magnification under polarizing microscopy (note the fine, needle-like crystalline structures).</p>

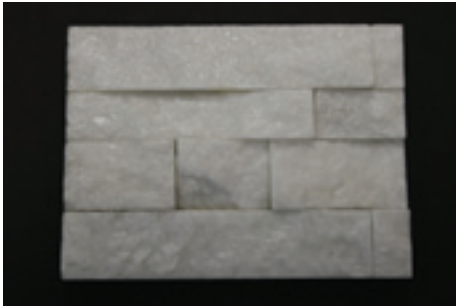
<p>(Front)</p>

<p>'Snow white' Tremolite asbestos-containing natural stone tiles. They come in a bright white colour and the surface has plates of crystals. Grooves can be felt on the surface of the plates.</p>

- Importers of natural stone tiles from China should ask for documentation that verifies the content of the tiles and ensure they do not import any tiles known to contain Tremolite asbestos or any other forms of asbestos-bearing rock.

- Importers or retailers who suspect they may have natural stone tiles that contain Tremolite asbestos or other forms of asbestos-bearing rock are to immediately inform WorkCover, and materials are to be tested by a National Association of Testing Authorities (NATA)-accredited testing facility.

- Where natural stone tiles are identified to contain Tremolite asbestos or any other forms of asbestos-bearing rock, they are to be sealed using appropriate plastic or leak-proof containers and disposed of as asbestos waste at an approved asbestos disposal facility.

- Where natural stone tiles containing Tremolite asbestos or any other forms of asbestos-bearing rock have been installed, the affected area is to be isolated until the material is removed by a licenced asbestos removalist and the area cleared by an occupational hygienist.
